# FireGuard

## Ceramic Mortar Joint & Resurfacing System

# designed to repair damaged and defective flue liners.

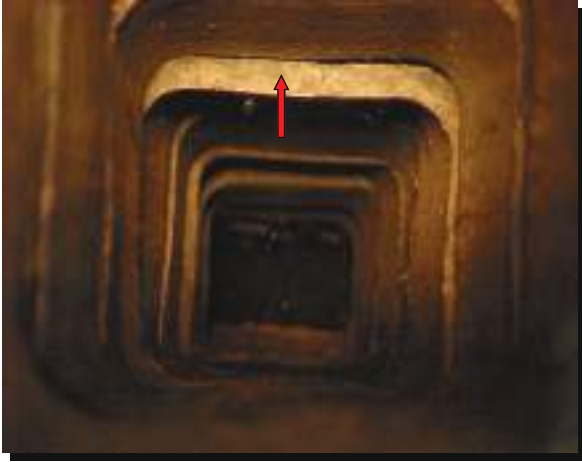
(1) Misaligned flue liners.

During original construction of a masonry chimney, it is not uncommon for masons to improperly align the flue liners or neglect to fill the joints between the flue liners with the appropriate refractory mortar (images 1 & 2). As stated in the 2006 International Residential Code, R1003.12 Flue lining (installation): *"Fireclay flue liners shall be laid in medium-duty refractory mortar conforming to ASTM C 199 with tight mortar joints left smooth on the inside..."* Additionally, thermal shock caused by chimney fires or over-firing of an appliance or fireplace causes clay flue liners to fracture (image 3). Settling or seismic vibration during an earthquake also causes flue liners to shift and fracture.

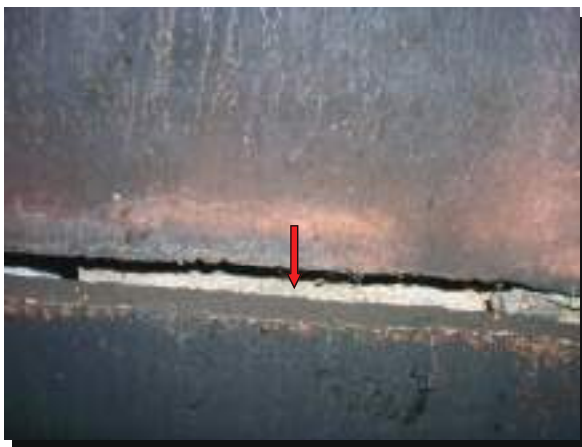
(2) Gap between flue liners as viewed through electronic scanner.

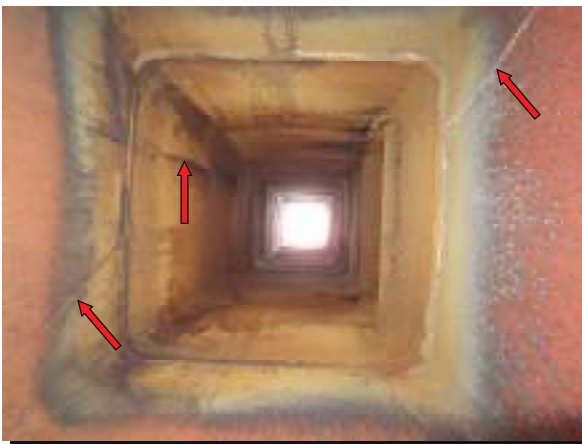
(3) Fractured flue liners.

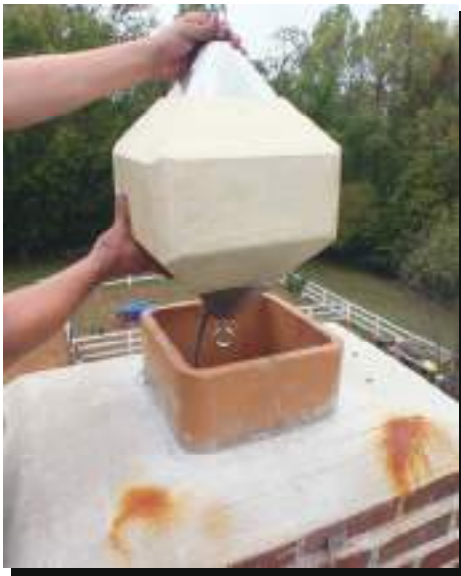
(1) A closed-cell applicator with an internal vibrator is installed in the top of the flue and winched down to the base of the flue.

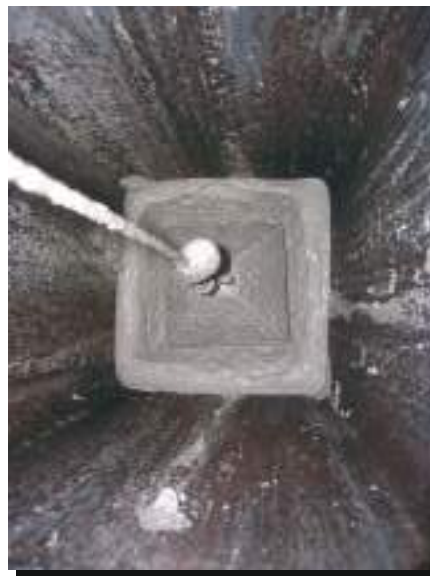
(2) The **FireGuard** material is then blended and poured on top of the vibrating applicator as it is winched up the flue. The applicator is drawn up and down the flue for multiple passes.

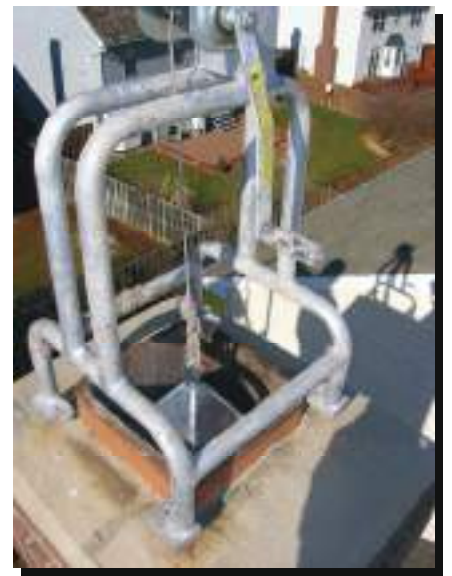
(3) Top winch is used to pull the vibrating applicator up the flue.

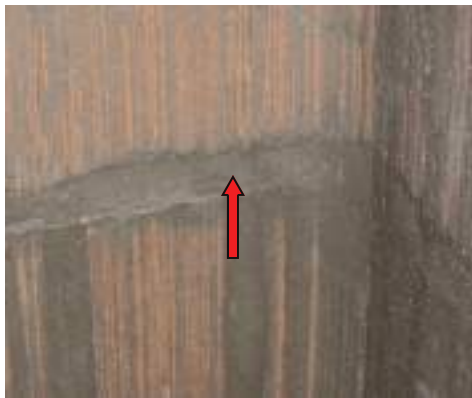
1" open mortar joint solidly filled.

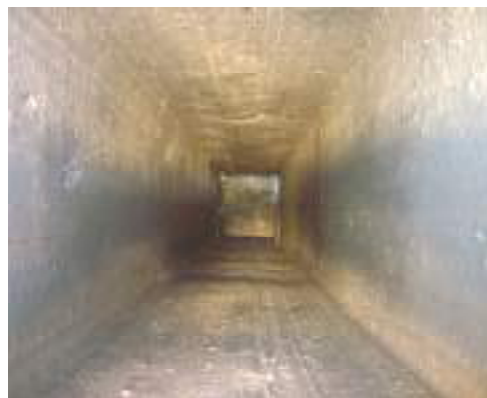
Fractured flue liners completely resurfaced.

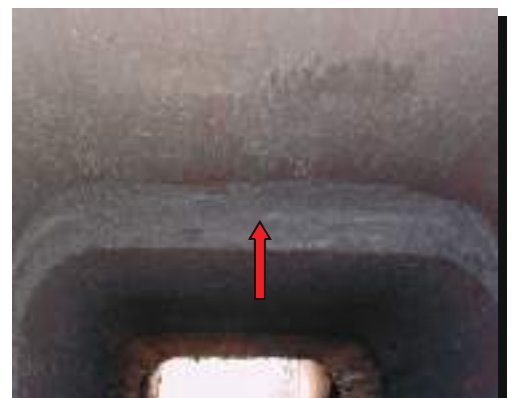
1" off-set between flue liners solidly filled.
